**BUNNELL
LAMMONS
ENGINEERING**

August 29, 2022

Subject: **Report of Limited Geotechnical Exploration**
Angel of the Lake - Infantino
Angel of the Lake Road
Lake Lure, North Carolina
BLE Project No. J22-18371-01

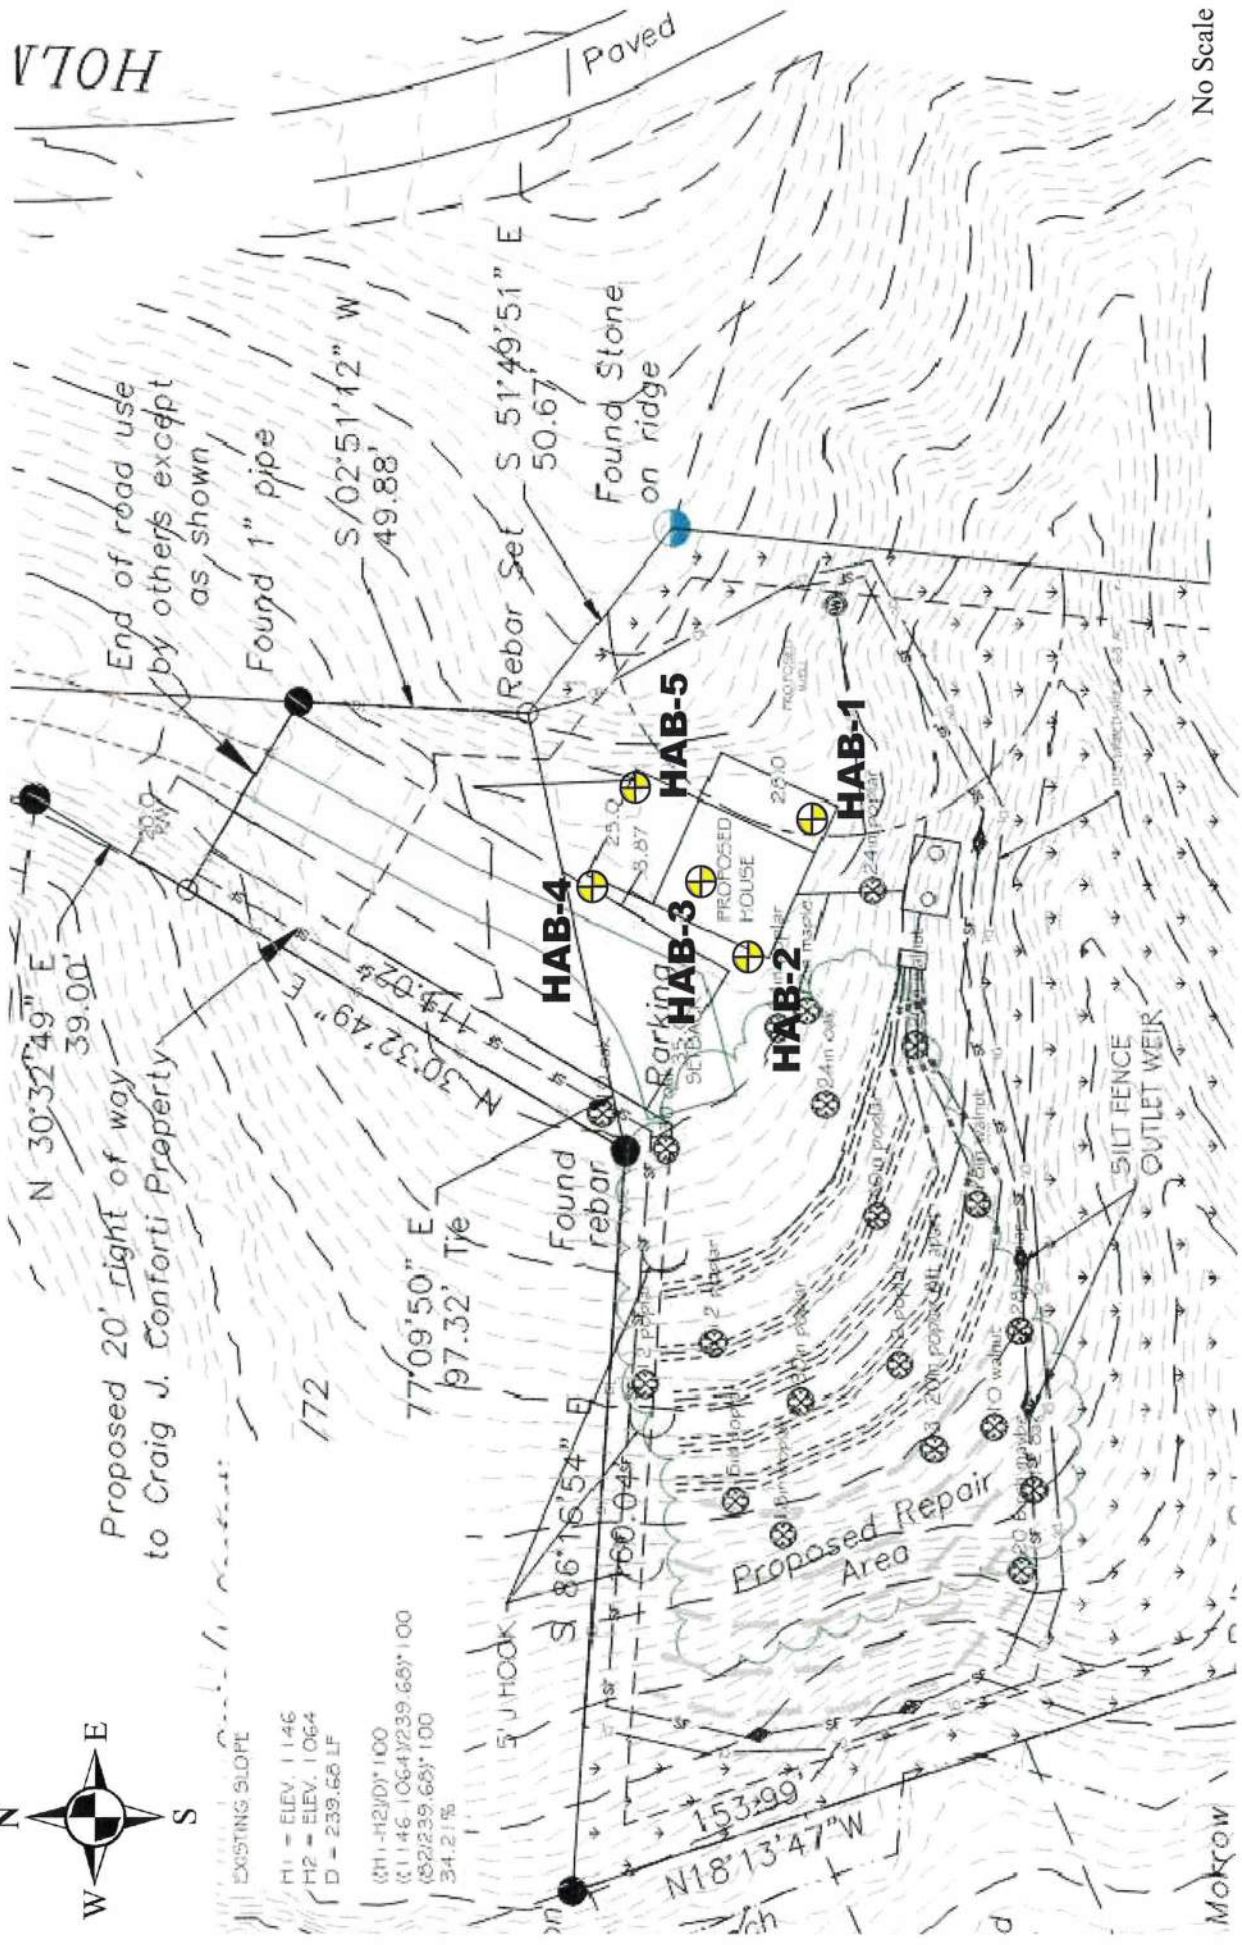
Drawn By: SCI Date: Aug 2022	Angel of the Lake - Infantino Angel of the Lake Road Lake Lure, North Carolina BLE Project No. J22-18371-01	Hand Auger Boring Location Plan	Figure No. 2
--	---------------------------------	--	------------------------------------	-----------------

EXISTING SLOPE
 H1 - ELEV. 1146
 H2 - ELEV. 1064
 D - 239.68 LF
 (H1 - H2) / D * 100
 (1146 - 1064) / 239.68 * 100
 (82) / 239.68 * 100
 34.21%
